HMMWV Electrical Issues

19 June 2019

HMMWV Battery Improper Install

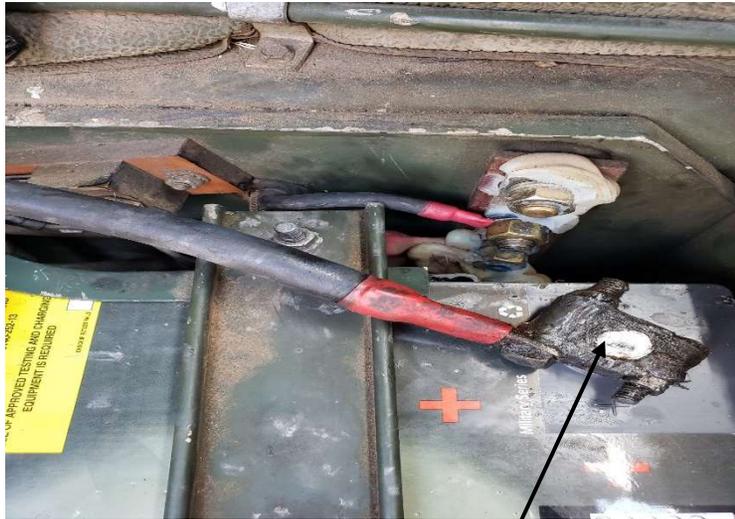
Picture of 4th Med Bn taken by SSgt Hartley, MFR Safety

Picture of CLB-453 HMMWV with 3D printed battery bracket.

Positive terminal closely located firewall creating a potential hotspot.

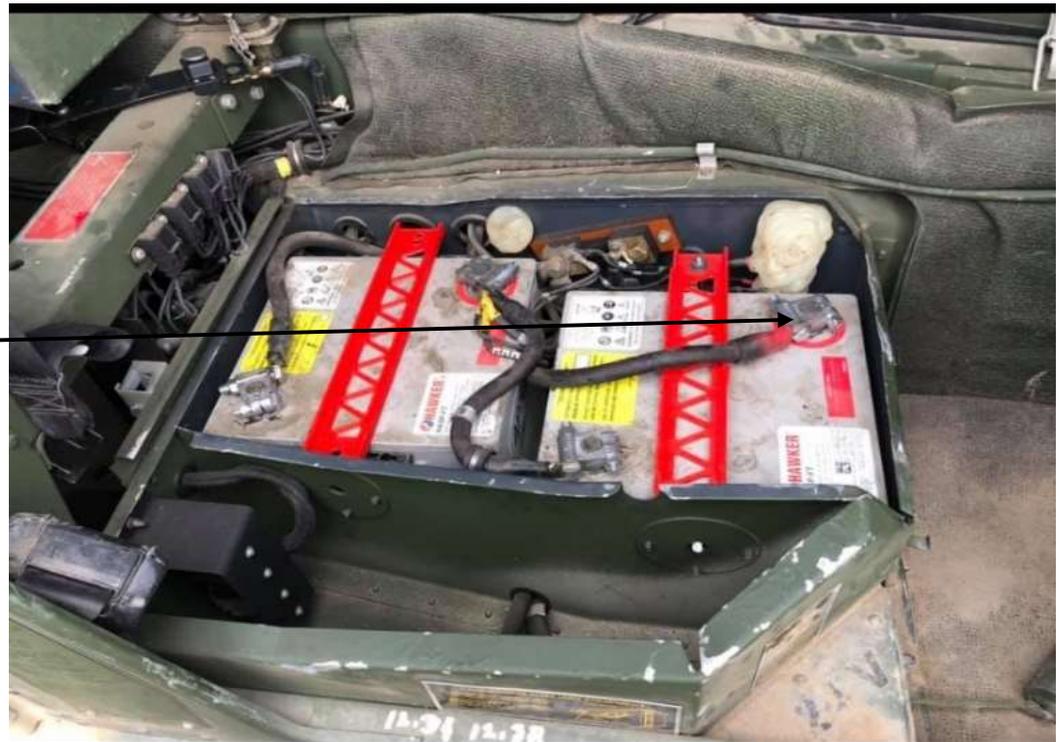
HMMWV Battery Proper Install

Positive battery terminals. Proper battery installation increases distance of positive battery terminal to junction box and potential of positive cables arcing.

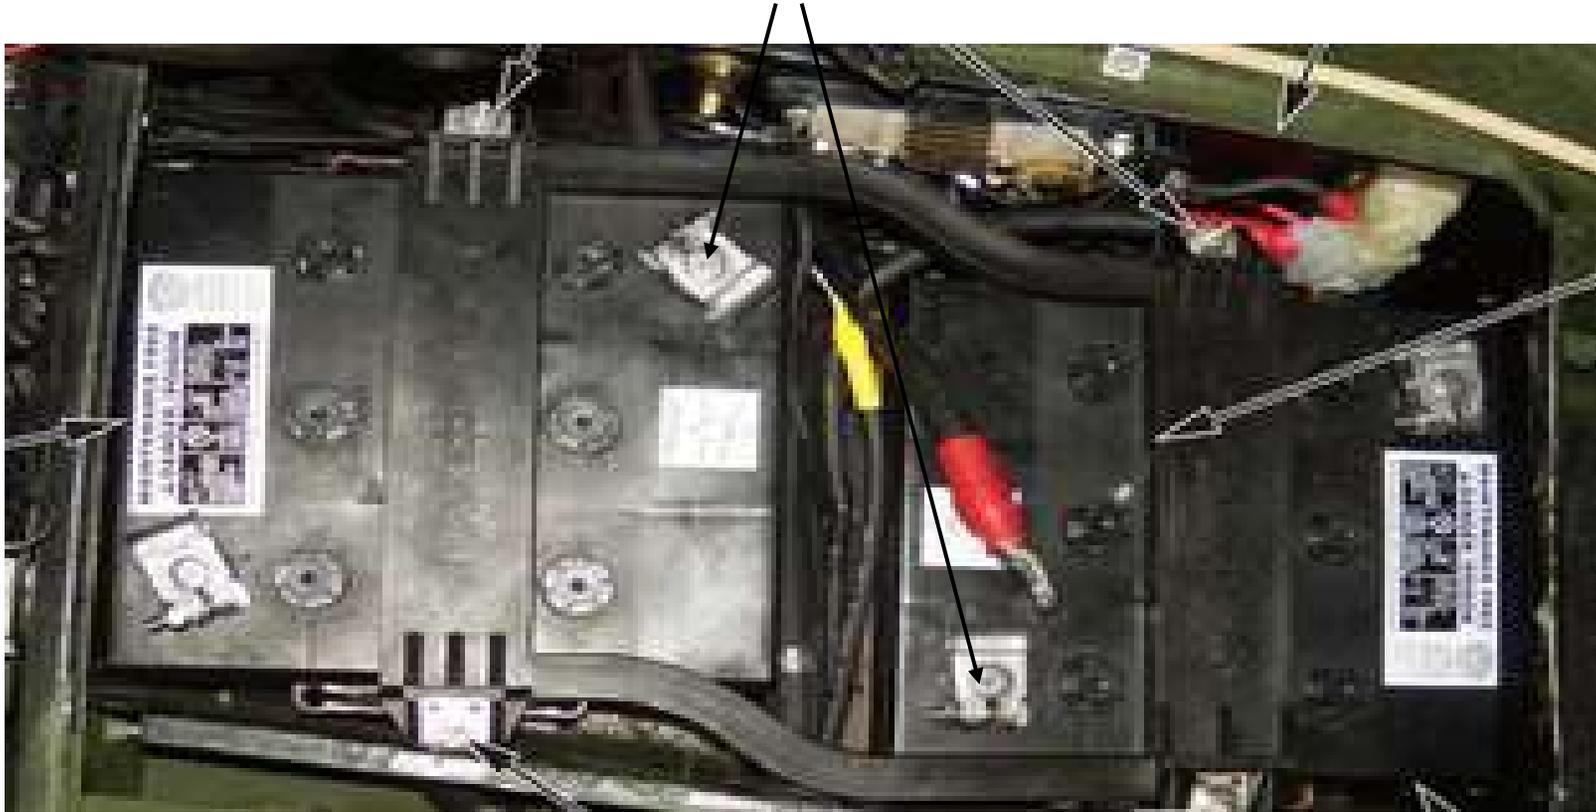
IETM Picture of properly installed batteries.

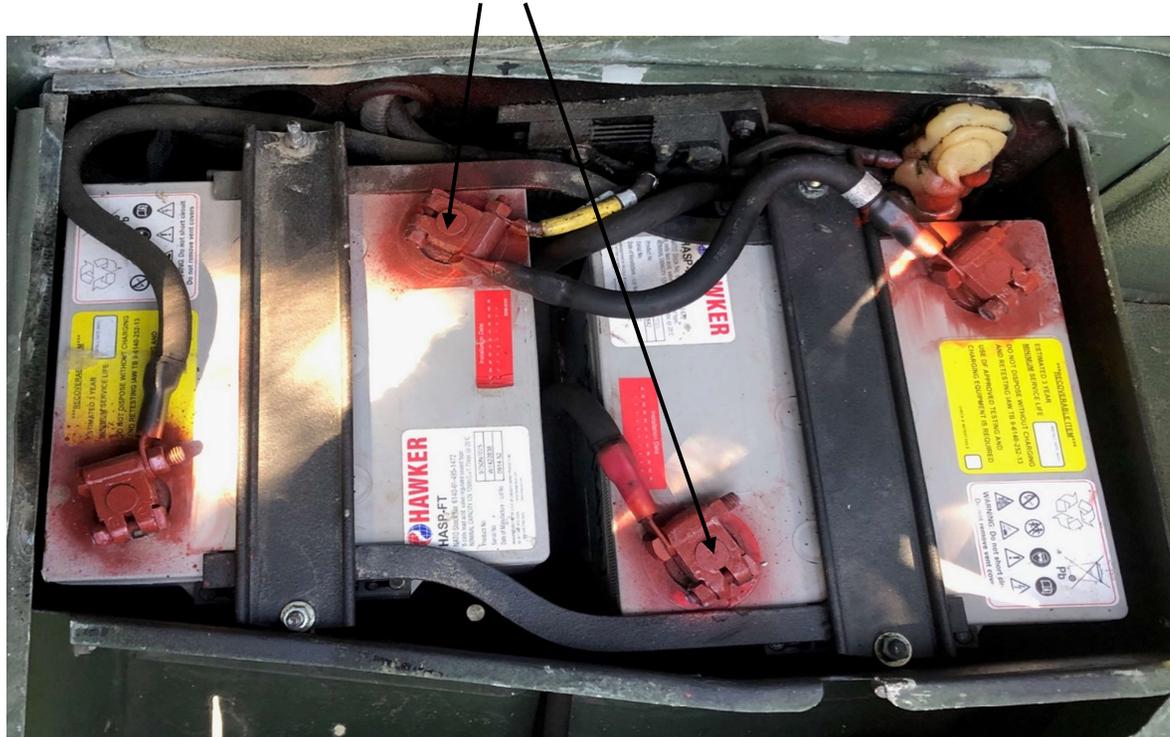
Positive battery terminals. Proper battery installation prevents arcing.

Picture of properly installed batteries provided by GySgt Maley, MLG G-4, of an Army HMMWV at Belle Chasse.

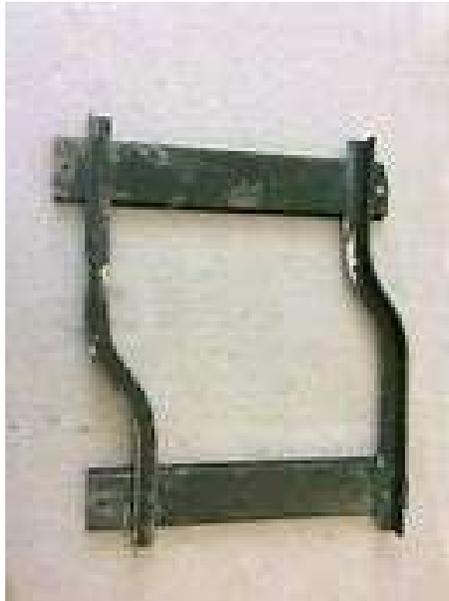
Battery Retainer

NSN 5340-01-414-0701
Old NSN for A2 variants
that was in PDF versions
of repair manuals. Use
until exhausted.

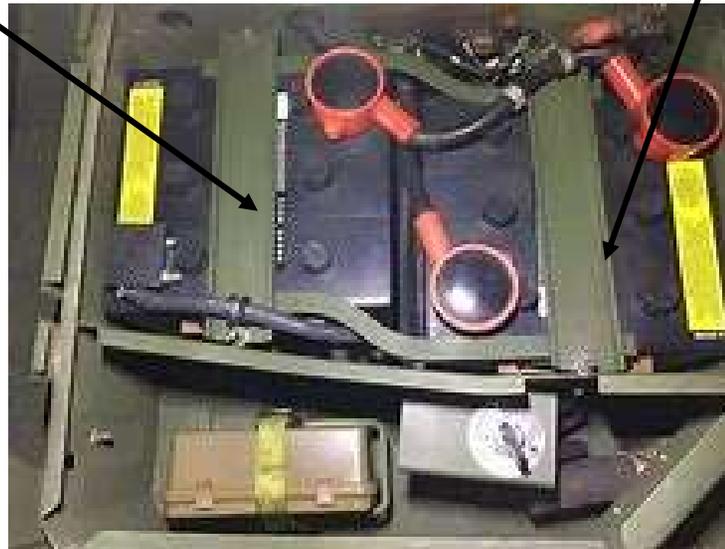
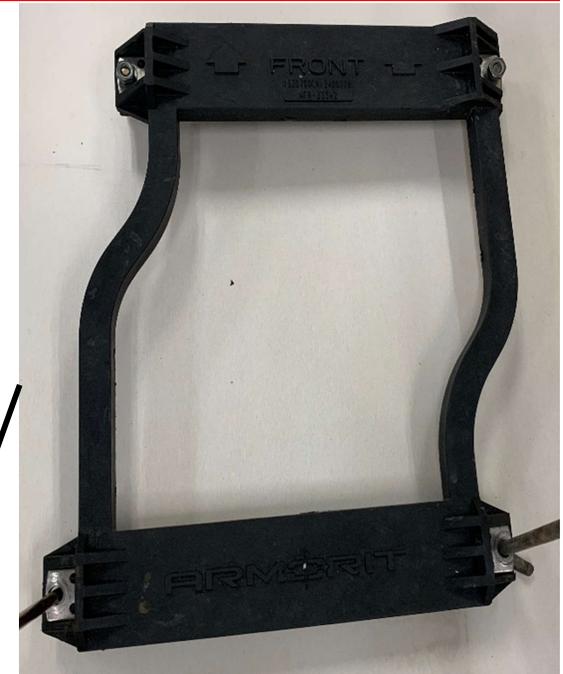
Example of both types of
battery brackets on the
HMMWV fleet.

NSN 6160-01-593-1062
Current IETM NSN for all
variants that is a bracket
composed of
polypropylene reinforced
with 40% long glass fibers.

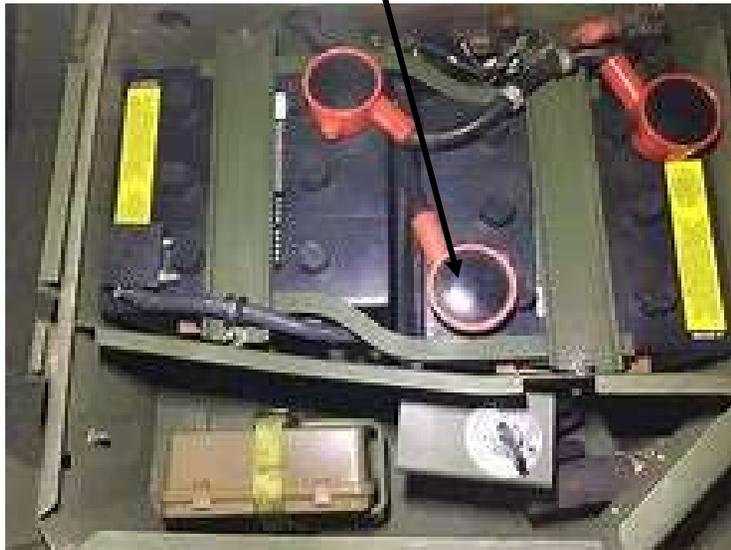
Battery Dust Covers

Dust covers and batteries properly installed.

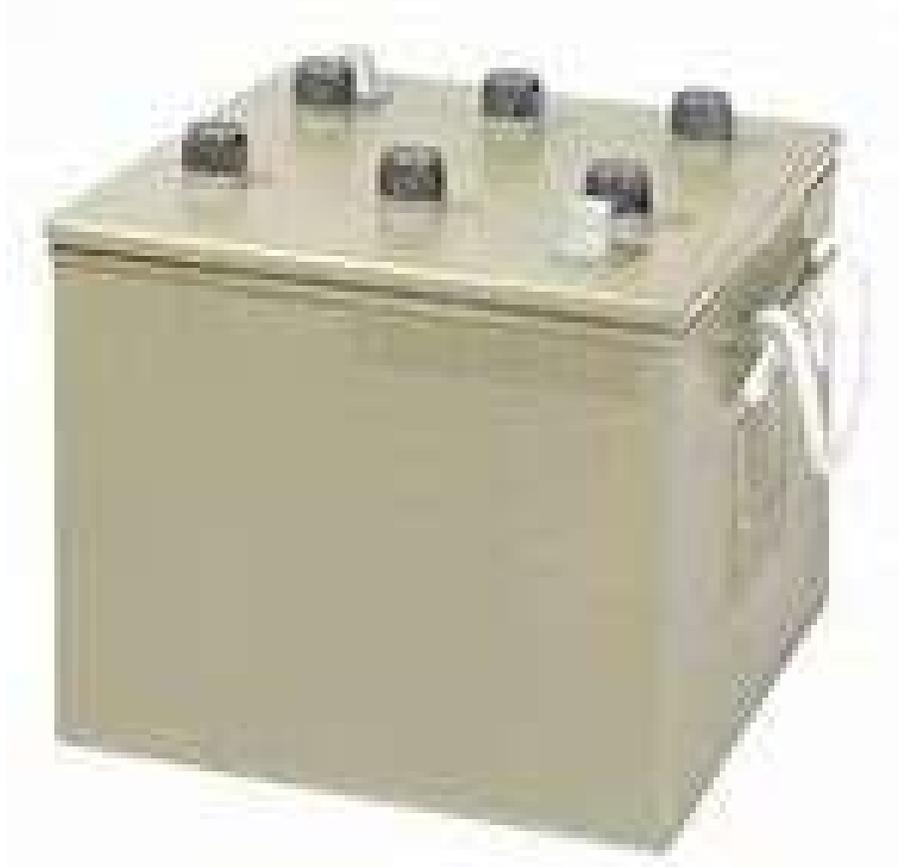
Wet-Cell Battery

This is the only authorized battery to be installed on the HMMWV family of vehicles per the PM office.

NSN 6140-01-446-9498
